LANDSLIDES AND RELATED FEATURES

OF THE CORBIN, KY. QUADRANGLE

Alfred R. Taylor and Roger E. Thomas

OPEN FILE MAP 82-653(H-16)

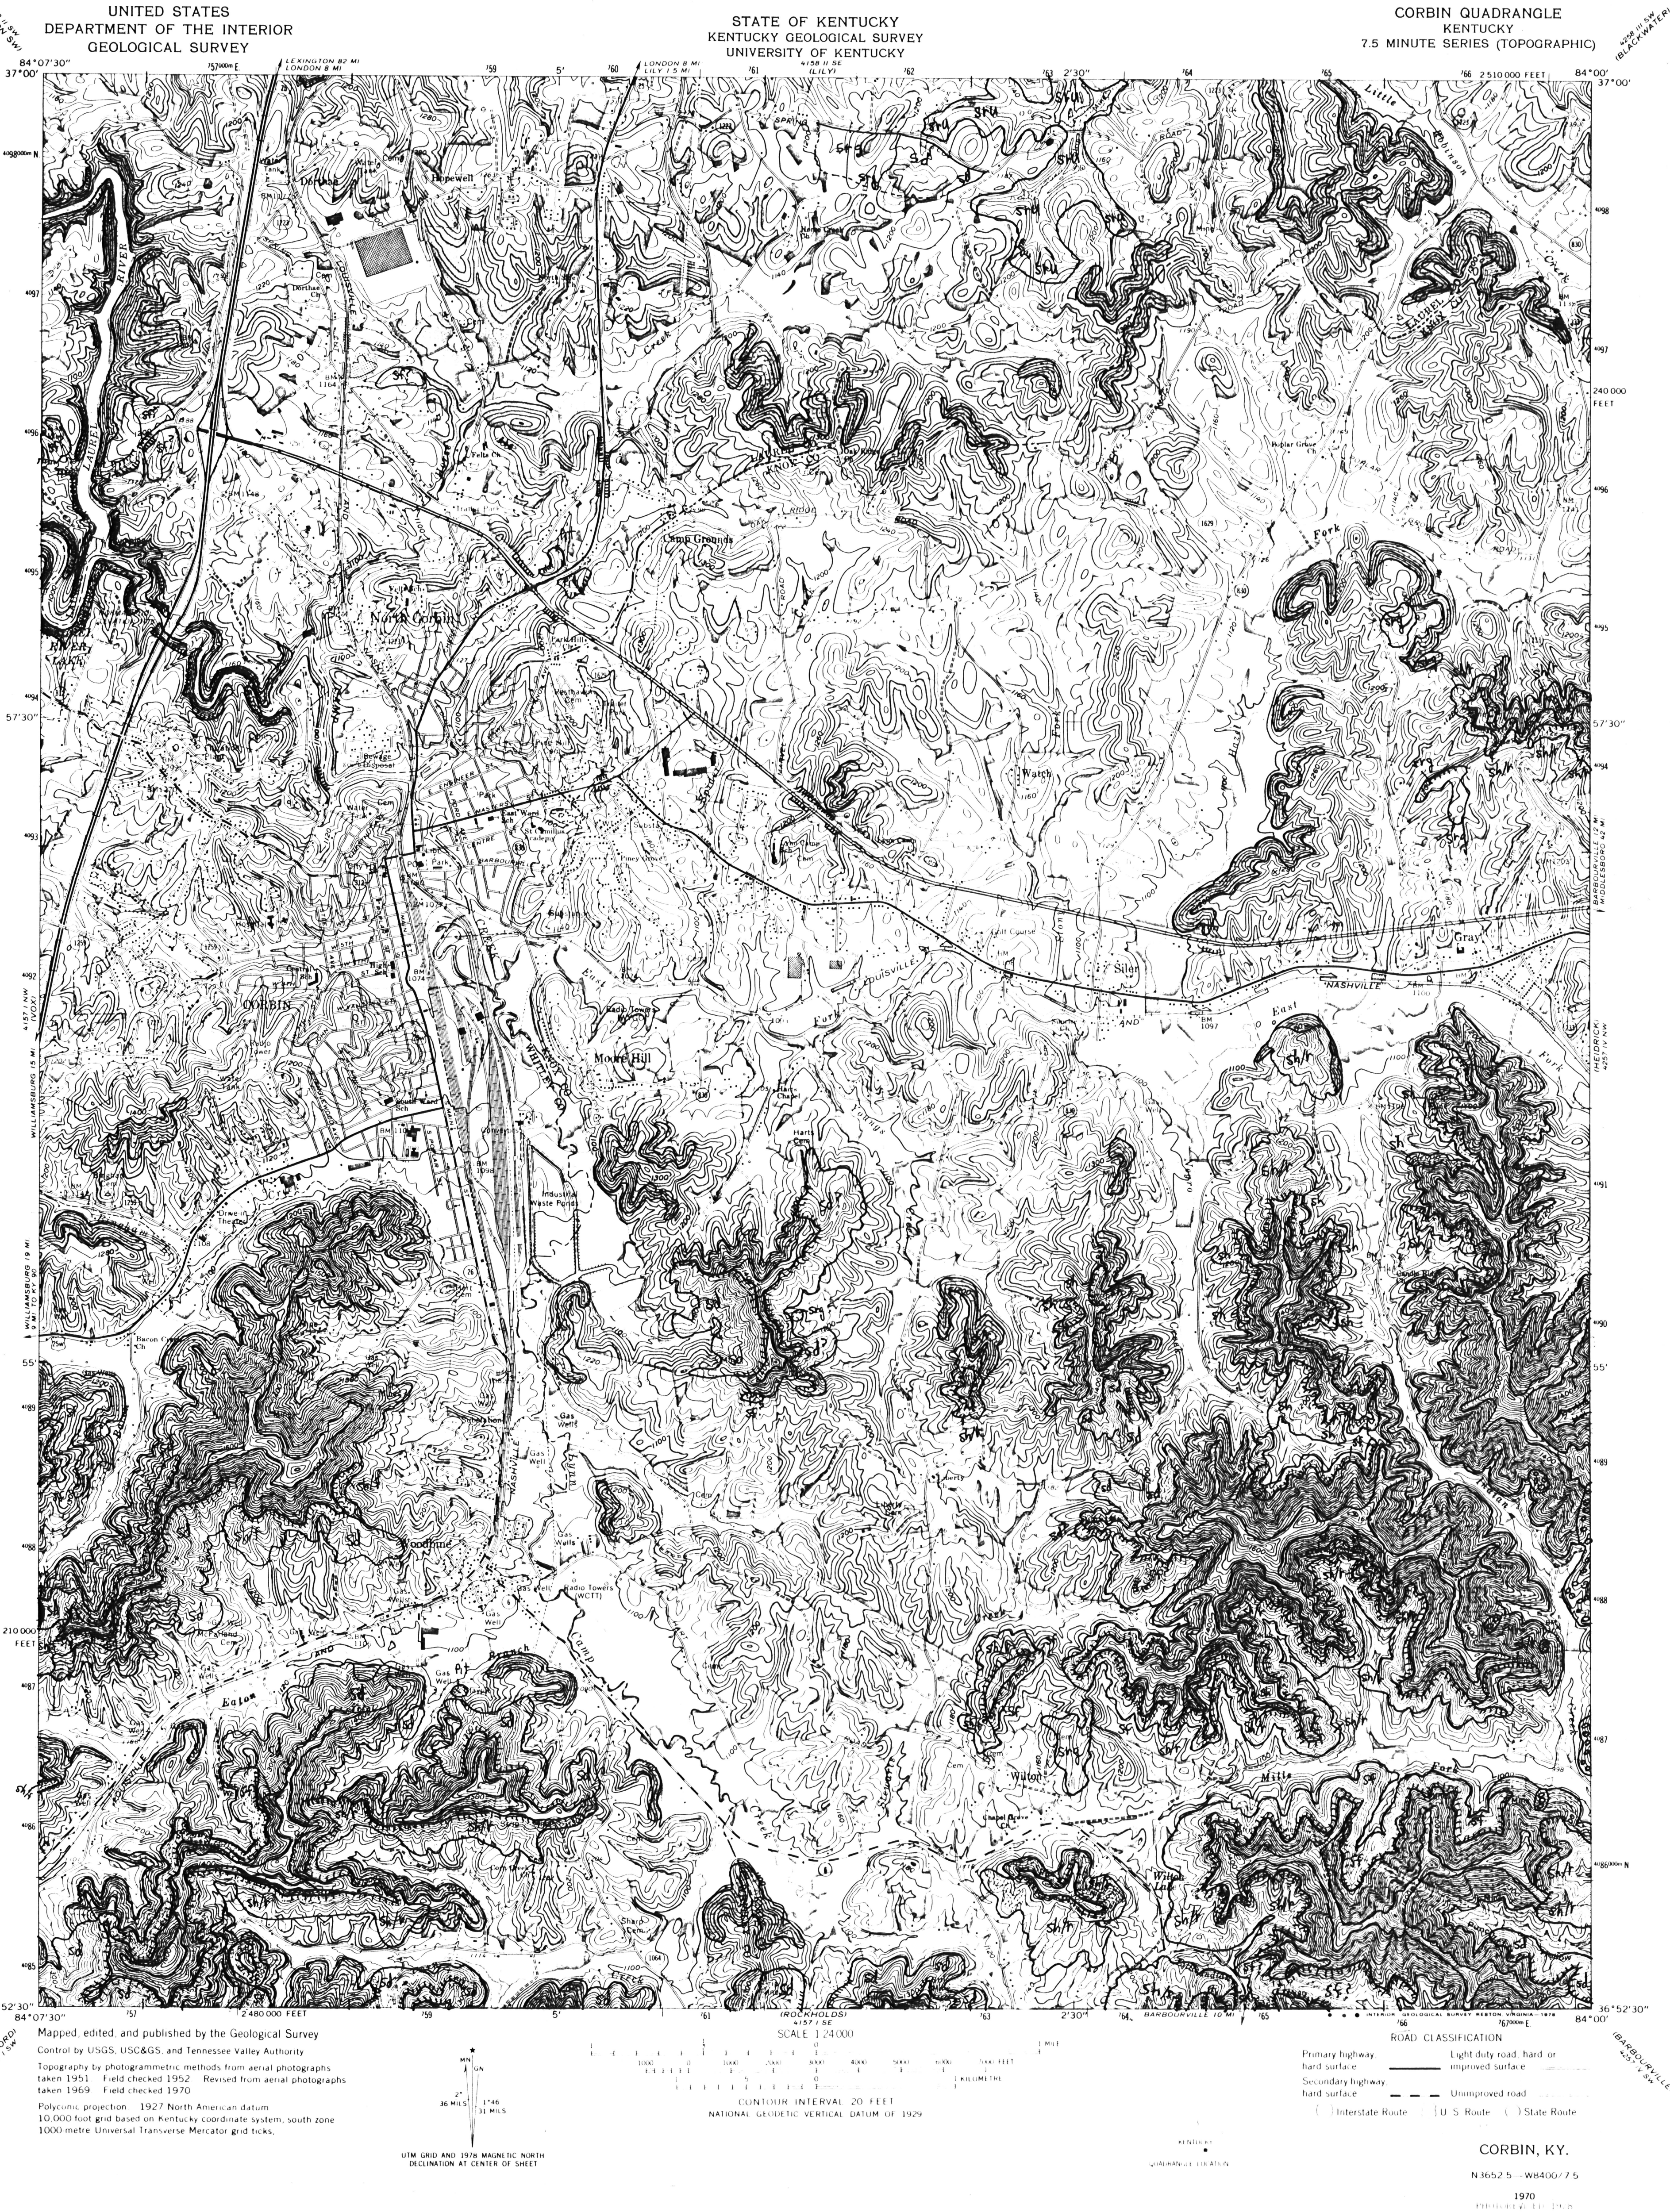
Landslides and related features interpreted from aerial photographs:

Photointerpretation and field check 1979-1980, 1982

Complex landslide composed of earthflow, debris slide, earth and rock slump. Identified from historical records, and from scars, debris and other field evidence. Ground extremely unstable; sliding accelerated by excavation, loading and changes in drainage conditions. May include areas with several active slides too small to be shown separately. Questioned where doubtful.

Area of extensive hummocky ground caused by earthflow and earth and rock slump. Lacks clear evidence of active sliding. Relatively stable in natural, undisturbed state, generally not affected by small structures properly sited in areas away from the edge of the toe; can be reactivated by extensive, rapid excavation, loading, and changes in ground water and surface water conditions. Area of old landslide probably includes recent ones not identified from field evidence or otherwise documented. Upslope boundary of landslide generally defined by modified scarp, but downslope (toe) may be gradational and not well defined. Questioned where doubtful.

Area of recent and old slides in which individual slides are not identified.

Valley wall along major streams with slope as steep as 40° (85%); stony, clayey silt soil up to 50 ft. (15 m) thick; commonly buttressed by a terrace or bench at the toe of the slope; very susceptible to sliding by cutting of toe area, removal of terrace or bench, and overloading; slide commonly activated without apparent cause.

Primarily shallow, narrow ravines and chutes with accumulation of stony colluvium generally 10 ft. (3 m) or less in thickness; susceptible to rapid movement during intense rainfall. Most ravines and chutes designated show evidence of former debris flows and avalanches.

Steep, locally vertical, natural and man-made slopes and cliffs, 15 ft. (4.5 m) or more high; formed dominantly of sandstone, limestone, sandy shale, mudstone and claystone. Interbedded mudstone, claystone and shale weather rapidly leaving sandstone and limestone rock faces unsupported.

Soil and rock similar to that involved in landslides elsewhere in map area; primarily areas underlain by claystone, mudstone and shale associated with other rock types. Rock weathers rapidly on exposure forming clayey soil highly susceptible to sliding. Includes coves (U-shaped, shallow valleys) containing thick layers of clayey soil that are very susceptible to sliding where excavation breaks continuity of slope and where overloaded by artificial fill.

Map areas in which no patterns or symbols are shown; primarily valley floors, ridge tops and broad benches; modification by excavation and fill may lead to local landslides.
